PHASE I ENVIRONMENTAL SITE ASSESSMENT REPORT

Row Townhomes

2323 West Broadway
Anaheim, California 92804

Report Date: September 2, 2020
Partner Project No. 20-289531.1

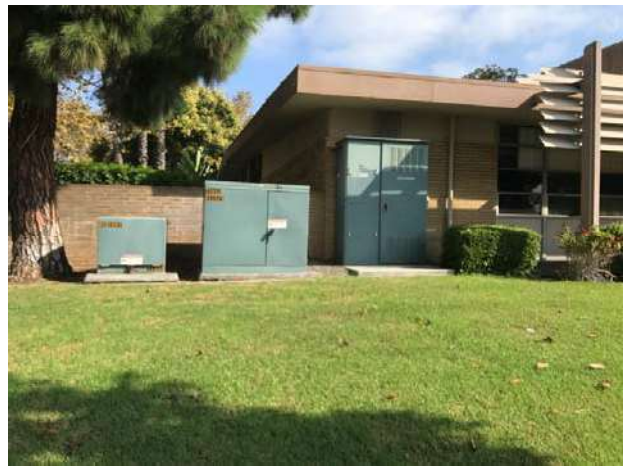
The on-site reconnaissance addressed indoor and outdoor transformers that may contain PCBs. Three pad-mounted transformers were observed on the subject property. The transformers are not labeled indicating PCB content and appeared to be utility-owned. No staining or leakage was observed in the vicinity of the transformers. Based on the good condition of the equipment, transformers are not expected to represent a significant environmental concern.

2. View of pad-mounted transformers.

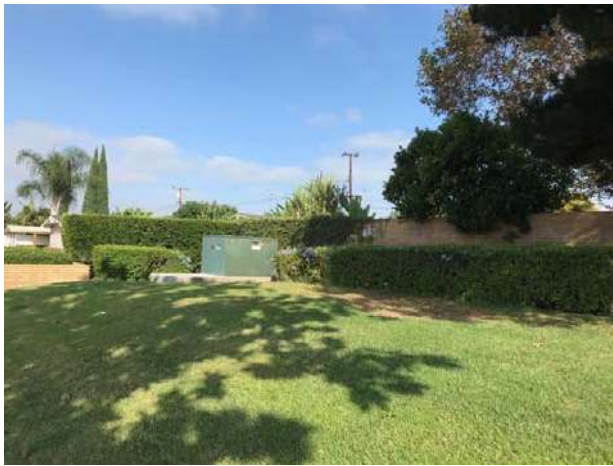
3. View of an additional pad-mounted transformer.

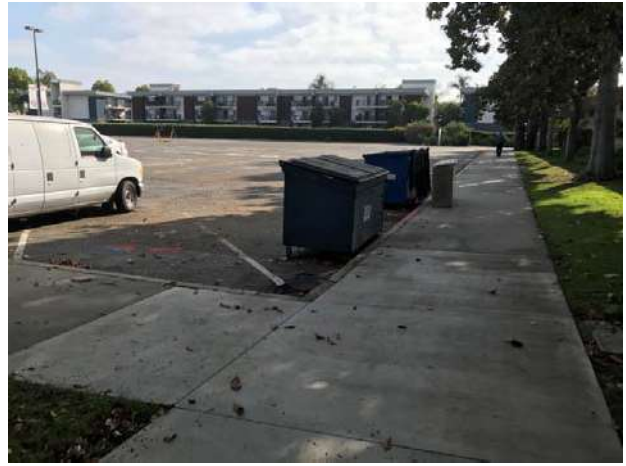
Solid waste is not currently generated at the subject property; however, commercial solid waste dumpsters serviced by Republic Services were observed on the subject property during the site reconnaissance. No evidence of illegal dumping of solid waste was observed during the Partner site reconnaissance.

14. View of the commercial dumpsters.

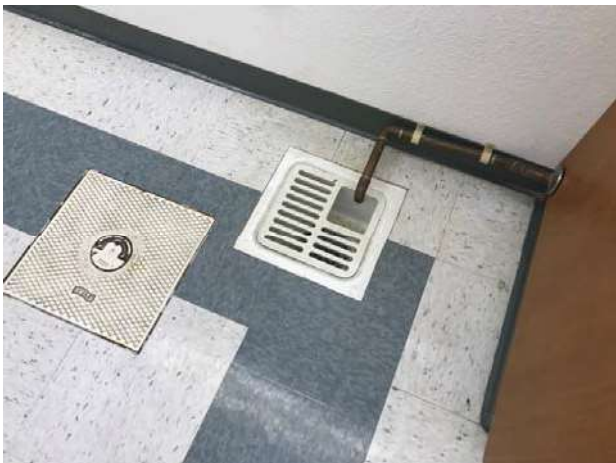
One floor drain was observed in the Main Office Building. Based on the nature of use for domestic purposes, this drain is not expected to represent a significant environmental concern.

29. View of a floor drain. In the Main Office Building.

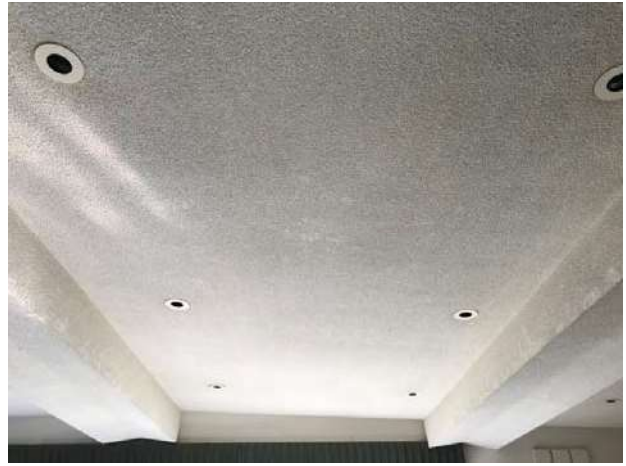
Suspect ACM	Location	Friable Yes/No	Physical Condition
Drywall Systems	Throughout Building Interior	No	Good
Floor Tiles	Throughout Building Interior	No	Good
Floor Tile Mastic	Throughout Building Interior	No	Good
Carpet Mastic	Throughout Building Interior	No	Good
Ceiling Tiles	Throughout Building Interior	Yes	Good
Spray-Applied Acoustical Material	Throughout Building Interior	Yes	Good
Stucco	Throughout Building Exterior	Yes	Good
Roofing Material	Roof	No	Not Assessed

38. View of popcorn ceiling.

Based on this building's date of construction, prior to disturbance, Partner recommends a comprehensive asbestos survey of the property be completed to determine the presence, condition, friability and likely future condition of suspect or confirmed ACM. All suspect materials must be handled as ACM according to local, state and federal regulations until the results of sampling and analysis indicate the material is a non-ACM. According to the US EPA, ACM that is intact and in good condition can, in general, be managed safely in-place under an Operations and Maintenance (O&M) Program until removal is dictated by renovation, demolition, or deteriorating material condition.

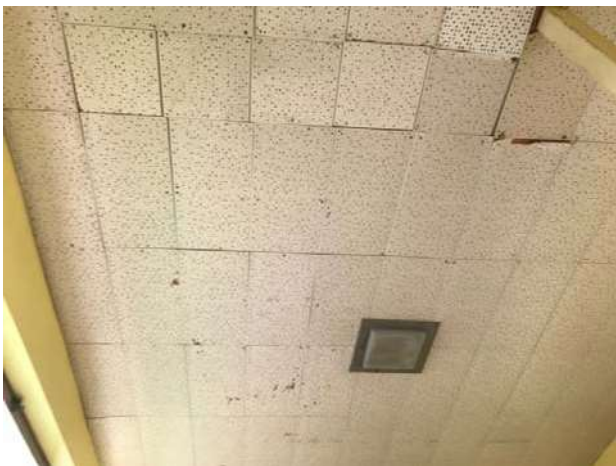
39. View of ceiling tiles.
